Austin Canyon Avalanche Fatality
1 Snowmobiler, fully buried and killed
Snake River Range, Idaho
April 3rd, 2020

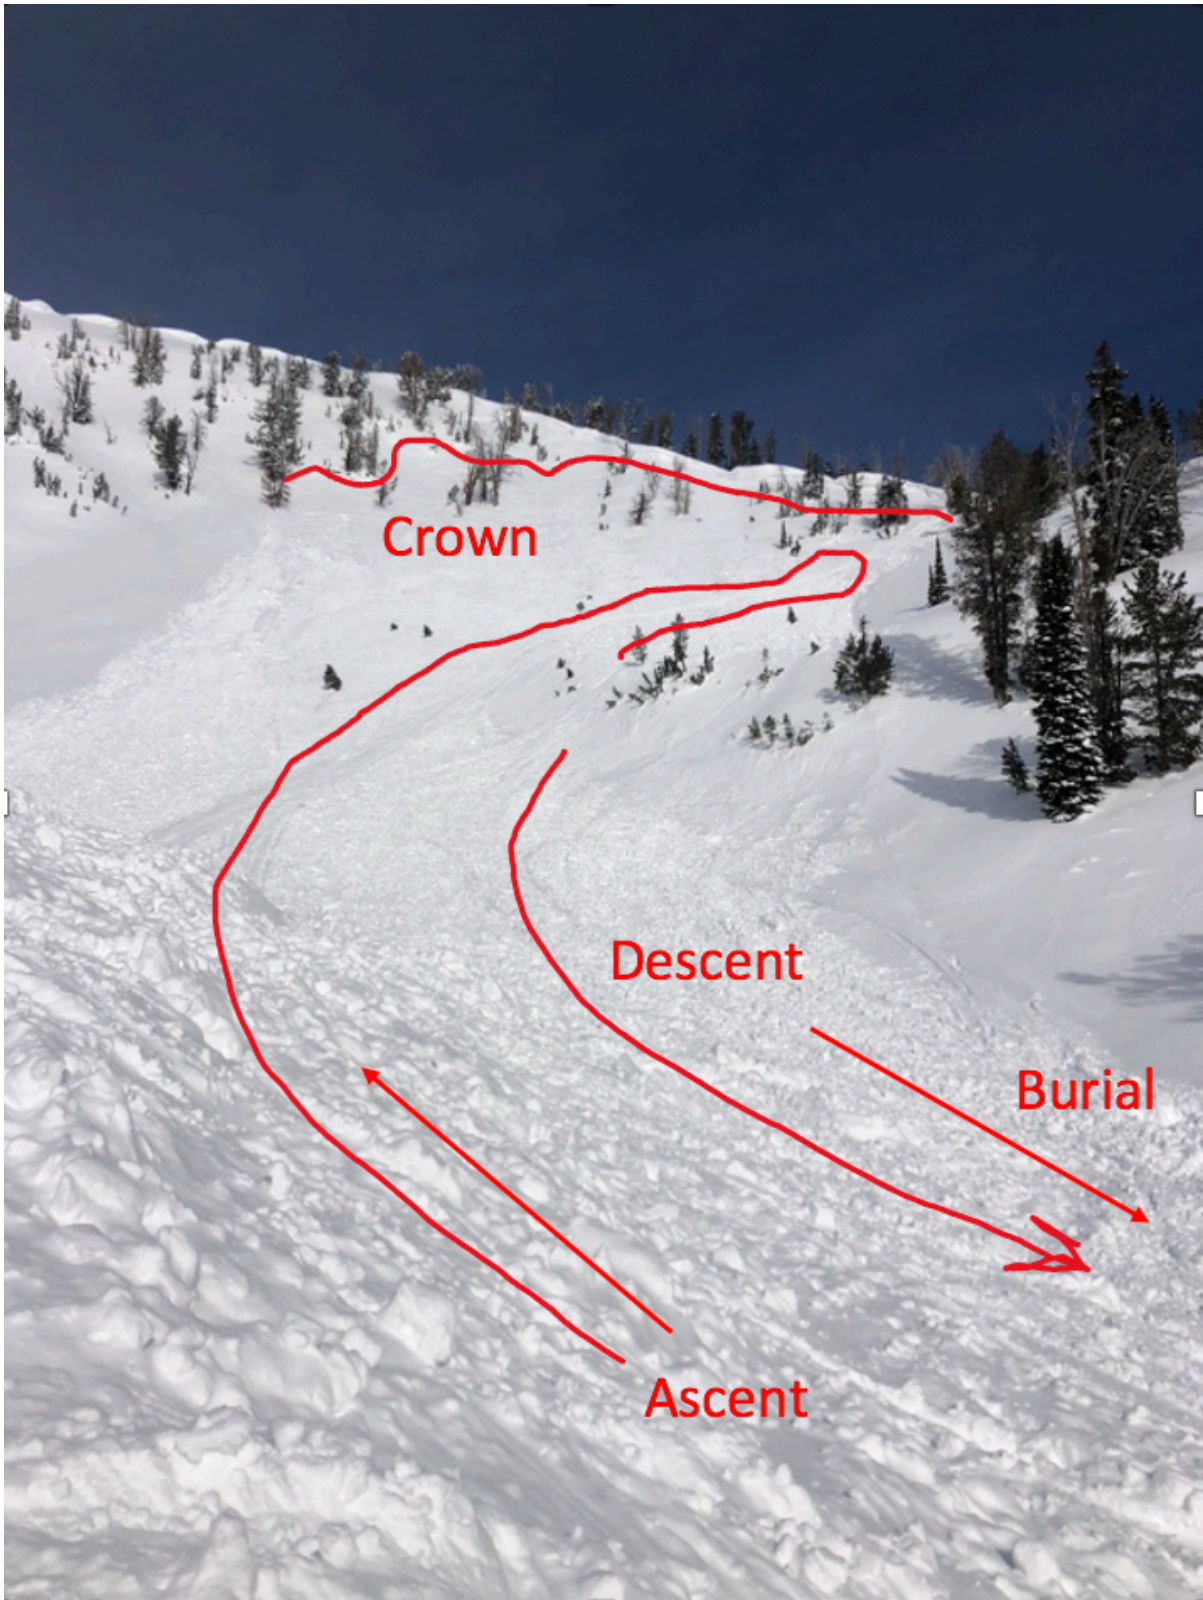
Estimated ascent and descent line. Rider 1 was buried outside of the photo near the left flank.

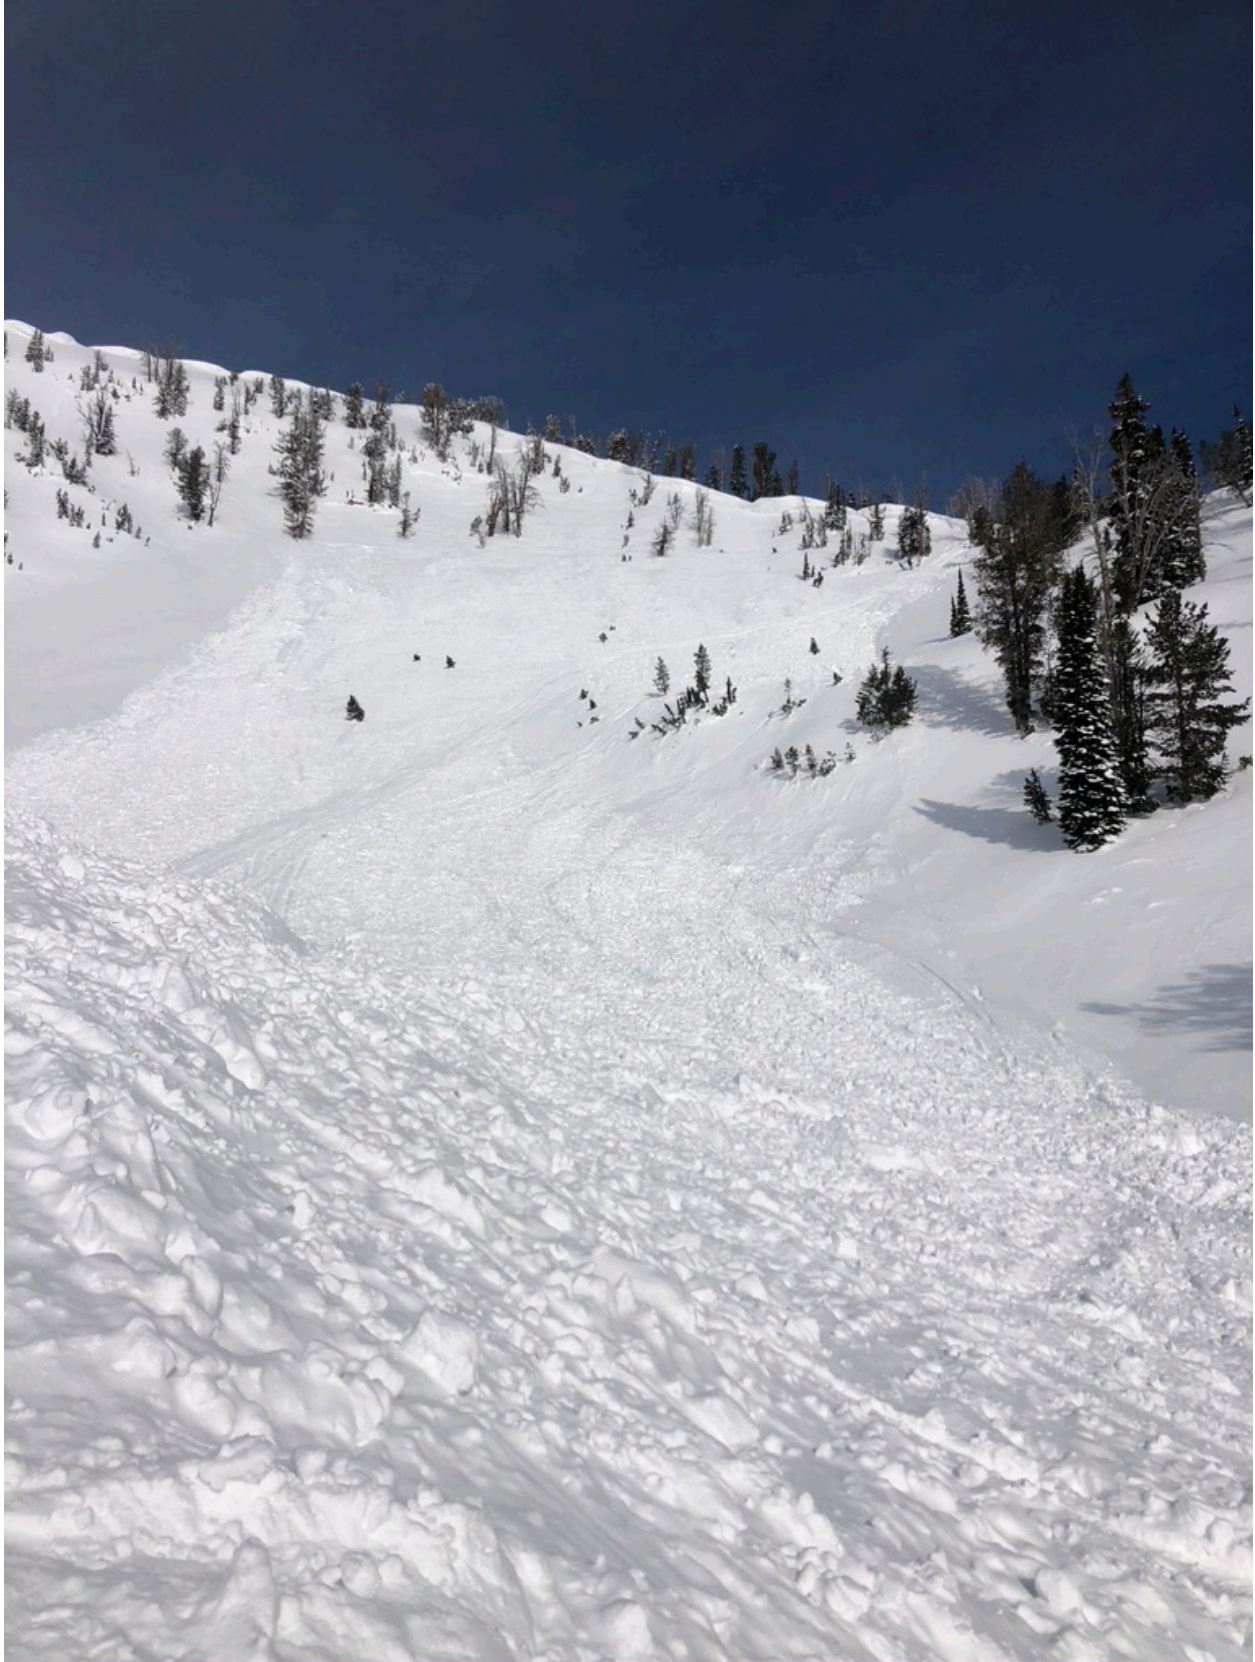
Looking up the slide path, both flanks are visible, the crown is visible below the cornice.

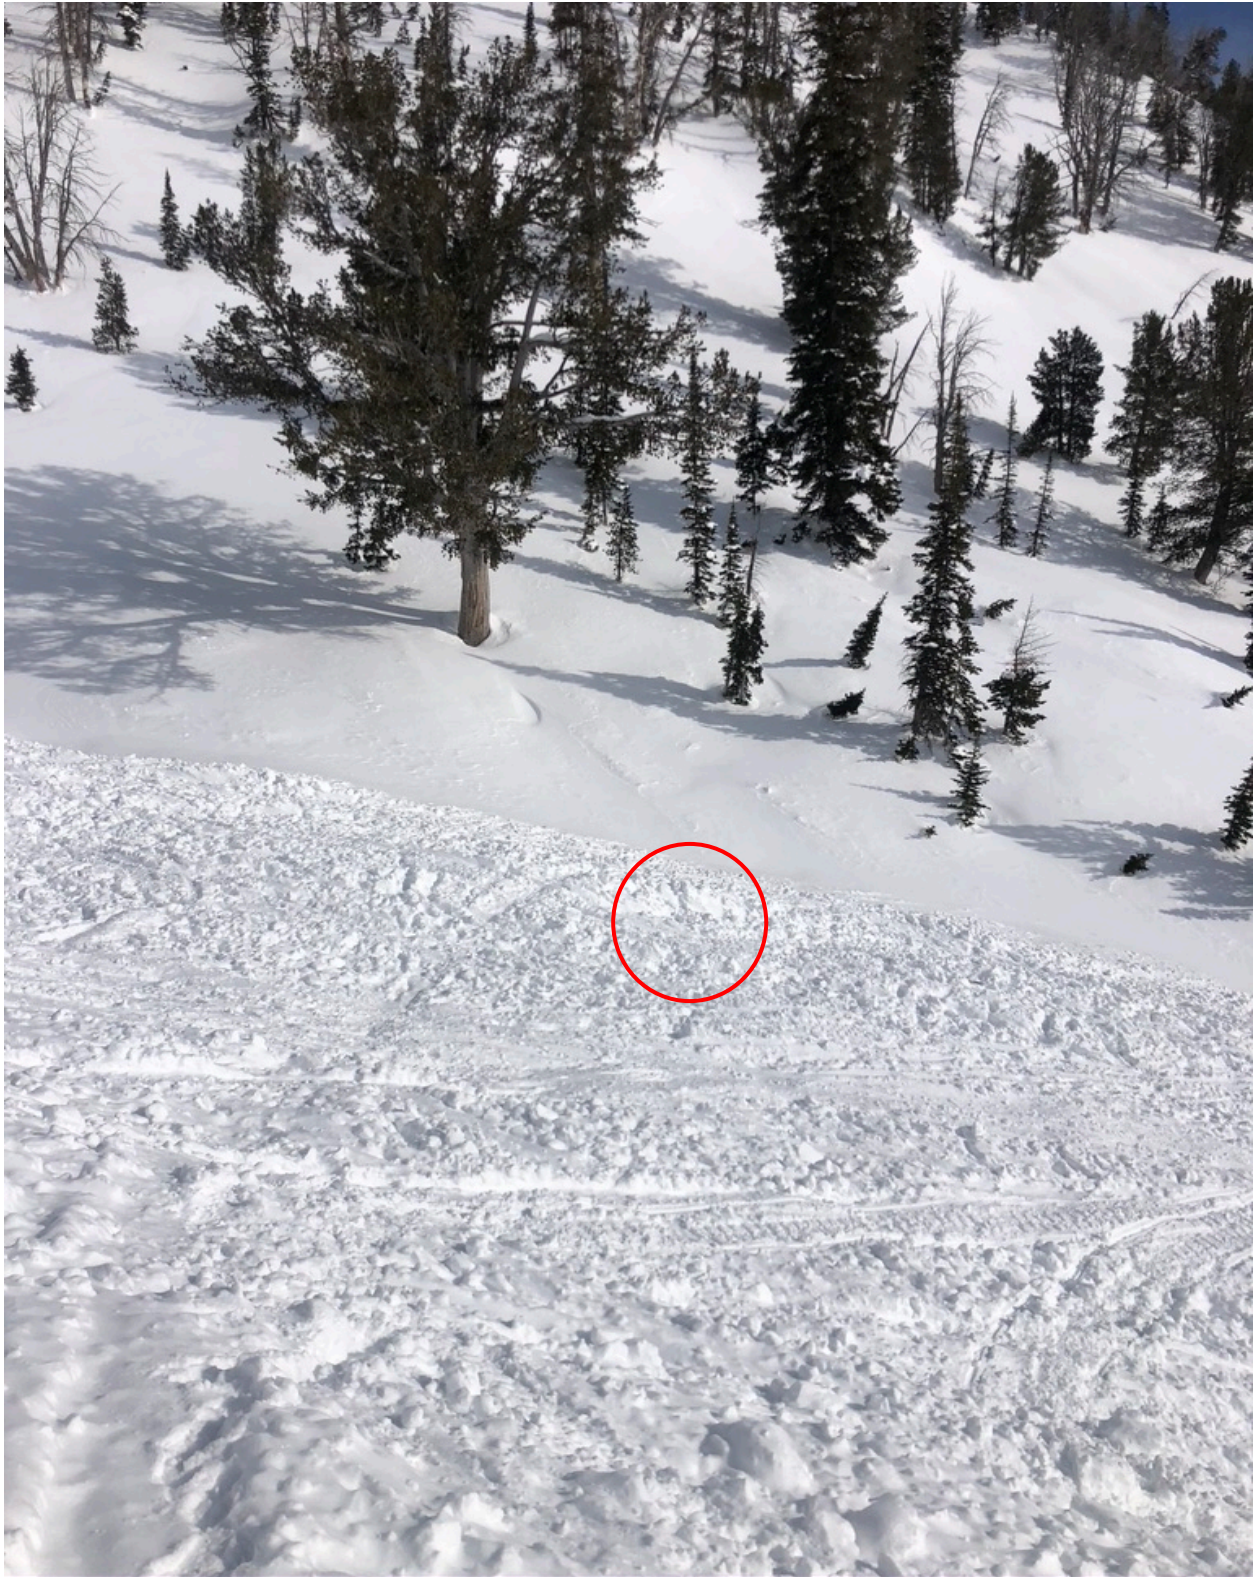
Approximate location of the victim.

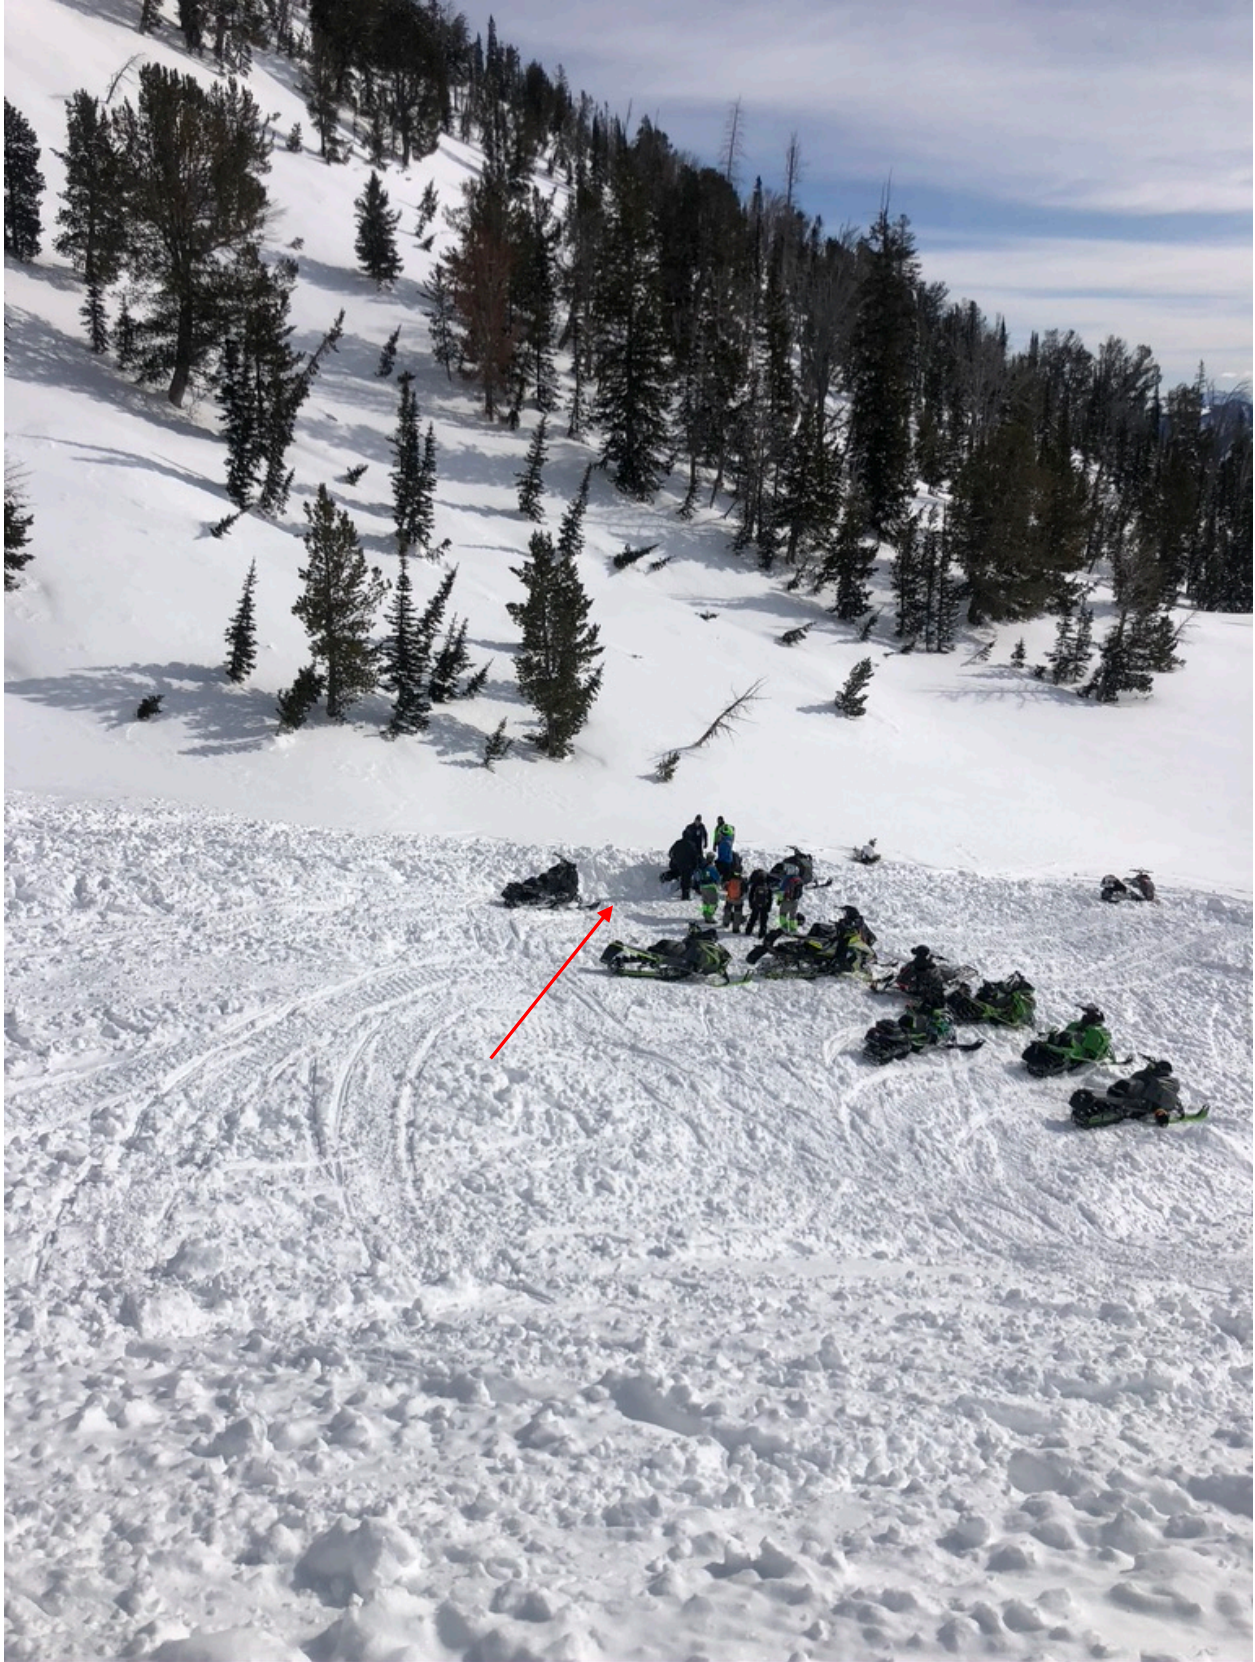
Approximate location of the victim's snowmobile.

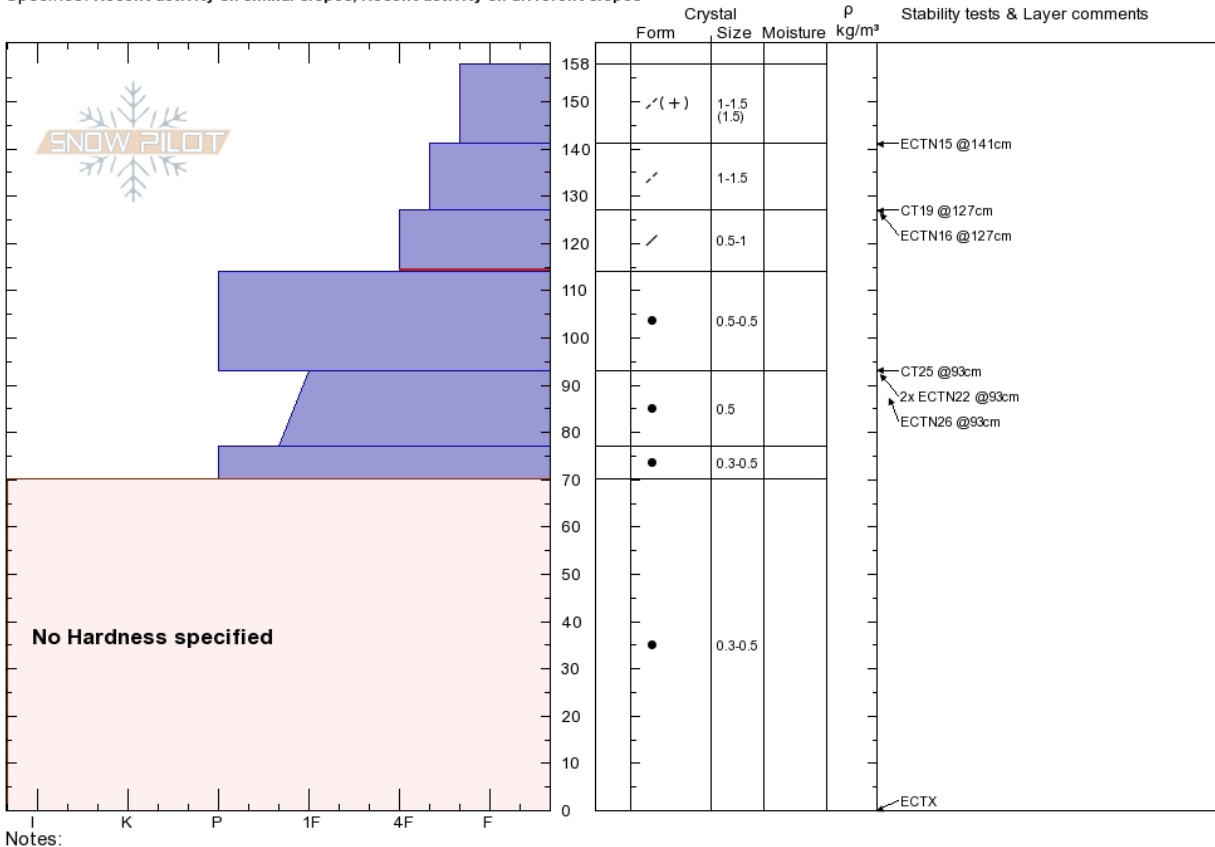
The day after the accident, a test pit was dug on a similar aspect and elevation. All failures were within the top 65cm of the snowpack (25.5"). There were no identifiable persistent weak layers and it is suspected that the avalanche failed on the new snow-old snow interface. It is likely the slope received additional wind loading that created a heavier load and more cohesive slab. The

day after the accident, the new snow appeared to be well bonded to the old snow surface and multiple extended column tests failed to produce full propagation. The snowpack structure beneath the new snow was strong and stable. The test pit was dug approximately 3.5 miles N/NE of the accident site.

Palisade Peak Bill Radecky Stability: HS:158 Layer Notes:
Teton Pass 04/04/2020 - 2:33pm Air Temperature: 127-114cm:Problematic layer
ID Co-ord: 43.43635N, -111.07775W Sky Cover: FEW
Elevation: 9459 ft Slope Angle: 23° Precipitation: NO
Aspect: SE Wind Loading: previous Wind: S Light Breeze
Specifics: Recent activity on similar slopes; Recent activity on different slopes
