Austin Canyon Avalanche Fatality
1 Snowmobiler, fully buried and killed
Snake River Range, Idaho
April 3rd, 2020

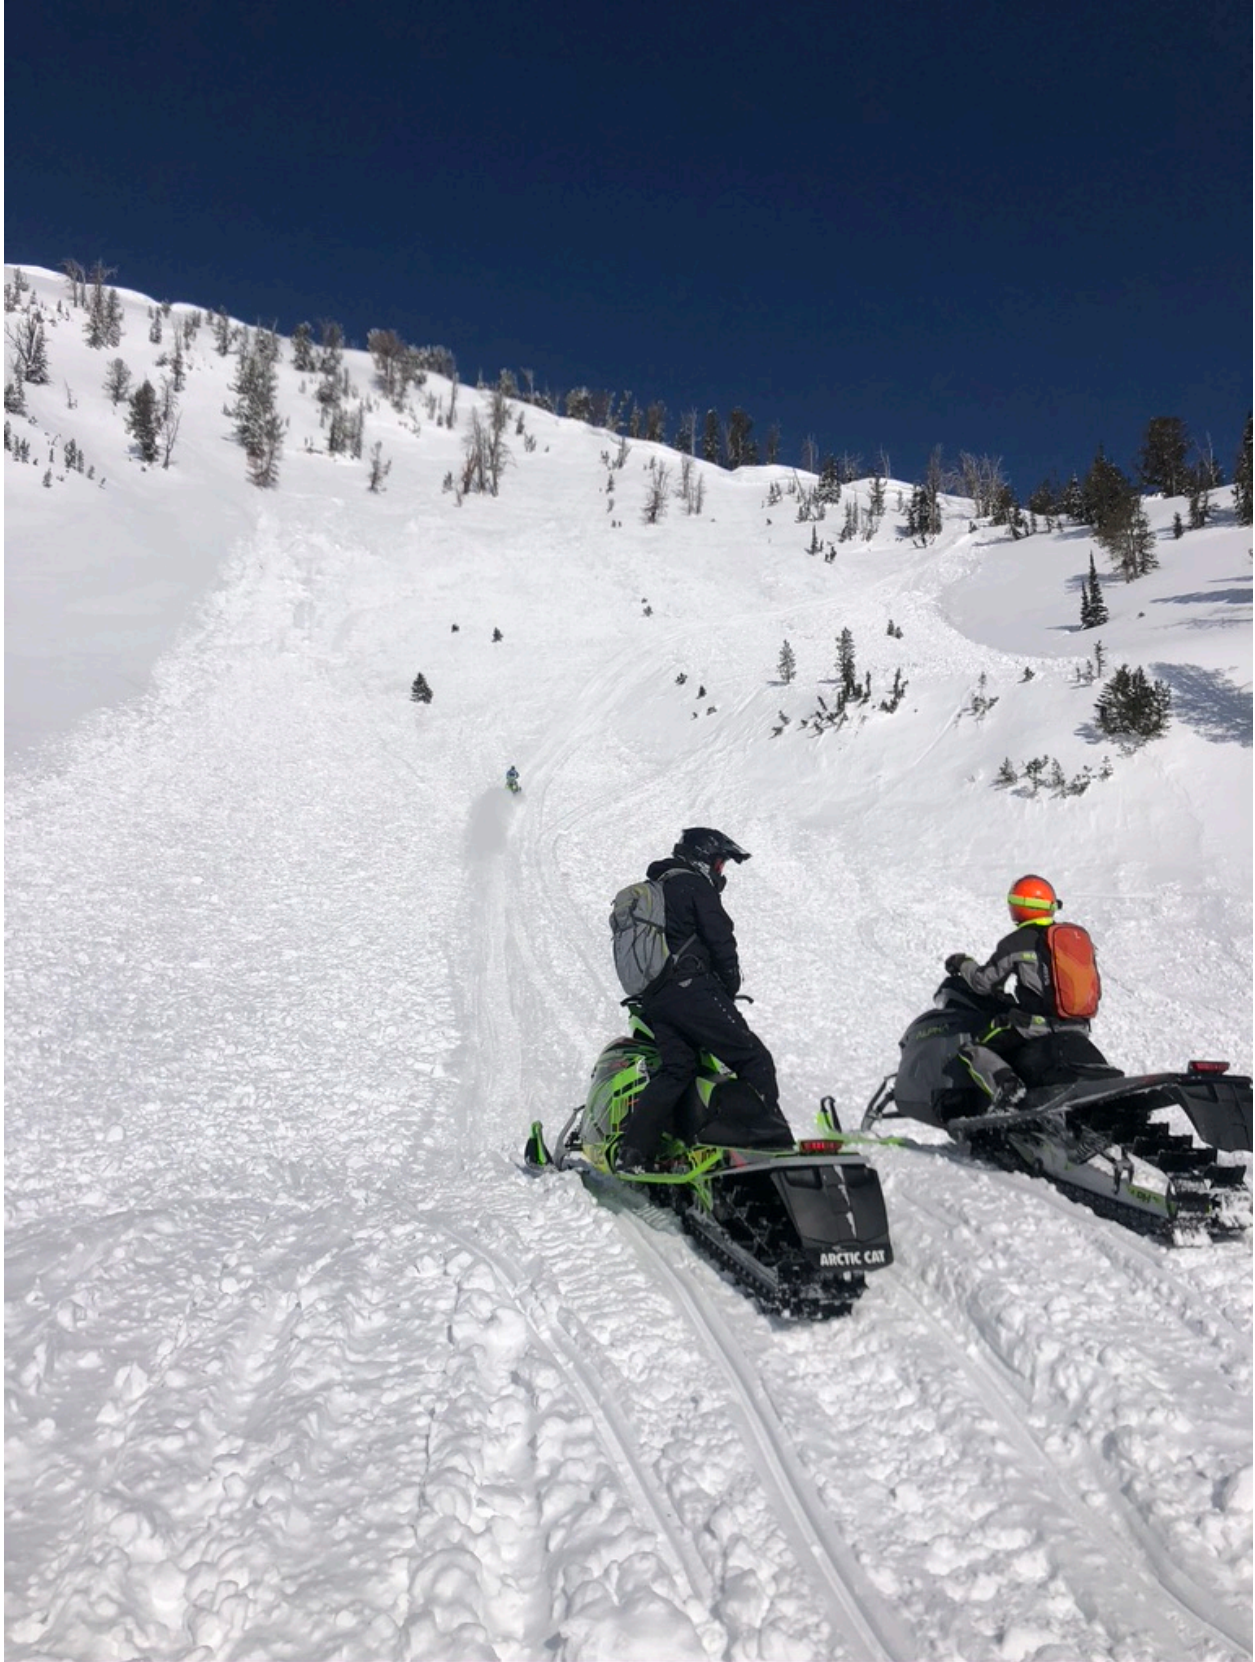
Exiting the accident scene on 4/4/2020 after the victim and his snowmobile were recovered.

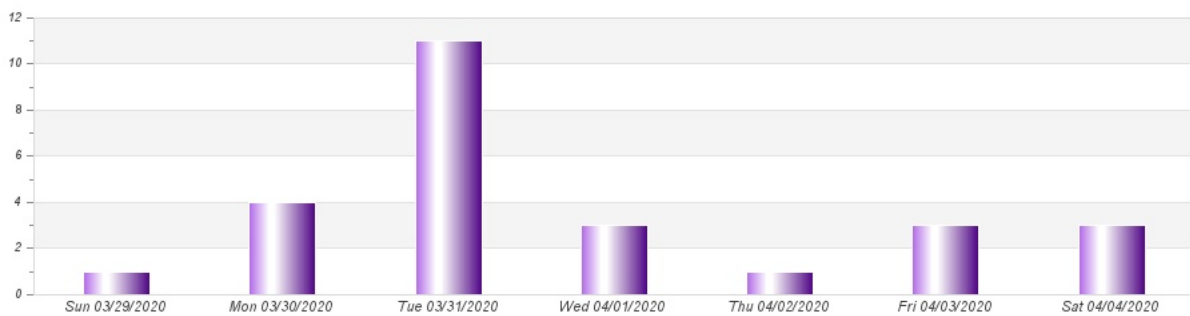
Snowfall for 7 days from Sunday 03/29/2020 at Bowl 9,580'

A significant storm dropped nearly 20" of snow totaling more than 2" of snow water equivalent (SWE) in the days leading up to the accident. The day of the accident, skies were partly to mostly cloudy and southwest winds were blowing an average of 16 mph. Mountain temperatures were in the teens F. Between 3/29/2020 and day of the accident, 4/3/20, 2.31" of SWE was recorded at the Raymer Study Plot in Jackson Hole Mountain Resort at 9,300 ft. All weather information was pulled from Jackson Hole weather stations located 18 miles from the accident site.

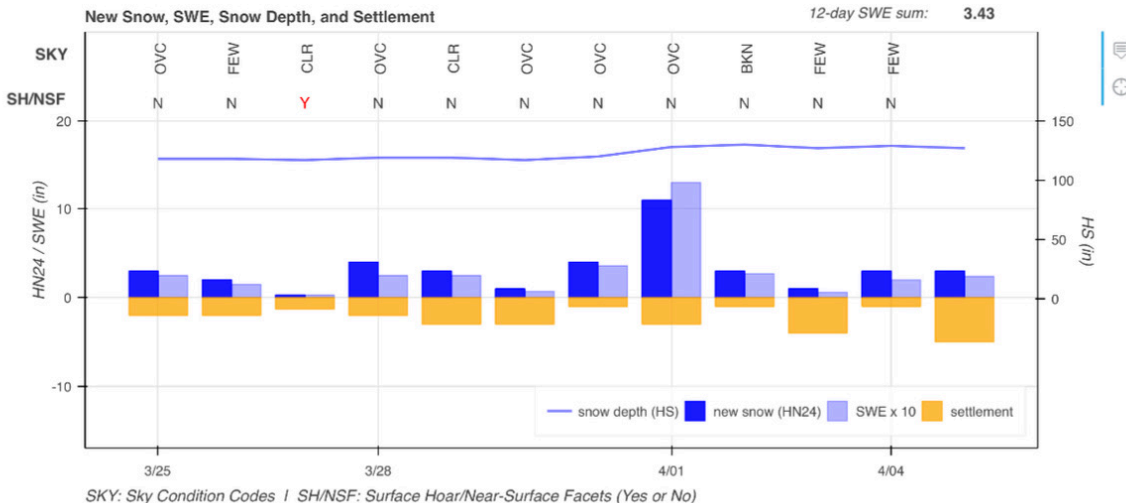
Mid Mountain Raymer Rendezvous Bowl

12-day new snow sum: 38.3

12-day SWE sum: 3.43

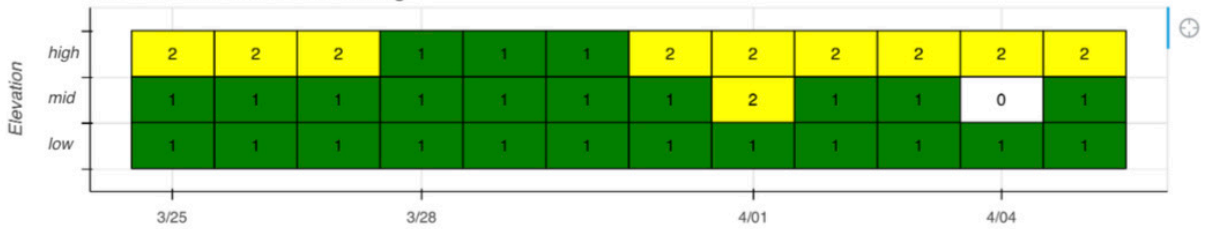
Teton Area Avalanche Hazard Rating

The Bridger-Teton Avalanche Center in Jackson Wyoming issued the daily avalanche forecast at 0640 on 4/3/2020. Members of the group read the forecast and were aware of the current avalanche problems. The forecast danger rating was LOW for low and mid elevations and MODERATE at upper elevations. Wind slabs were the primary avalanche problem at upper elevations on all but west facing aspects.
